**Flood Control Project Maintenance
Levee Inspections**

Fall 2016 Levee Maintenance Deficiency Summary Report

Reclamation District No. 0544 Upper Roberts Island

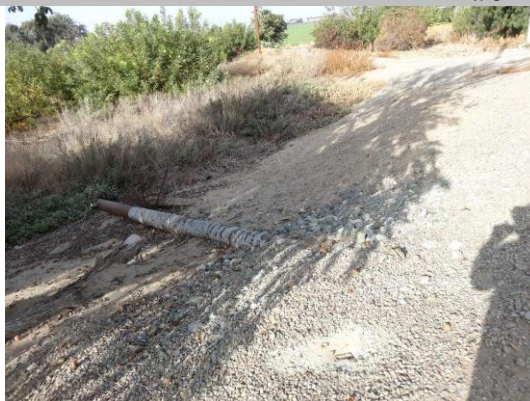
Photo 1 of 2 : UCIP_FA_2016_23851_41728.jpg

LM Start	0.01	Rating **	M	Issue No.	168 (cont)
LM End	0.01	Issue Type +	En	Location *	N/A

LS view: exposed 12-inch steel pipe on levee slope. Appears abandoned.

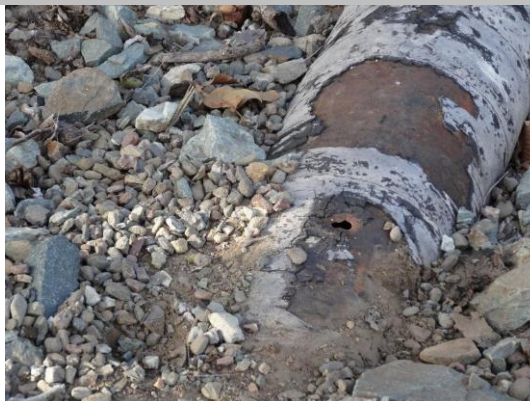
Photo 2 of 2 : UCIP_FA_2016_23851_41727.jpg

LS view: a 12-inch steel pipe on levee slope. Holes on the pipe, appears abandoned.

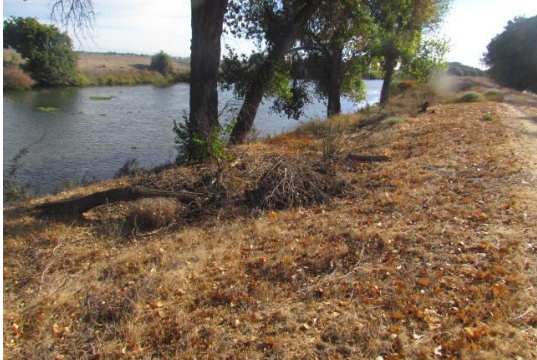
Photo 1 of 1 : FA_2016_RD0544_108_6_20160929_00010.jpg

Looking northeast at broken concrete piping on waterward berm.

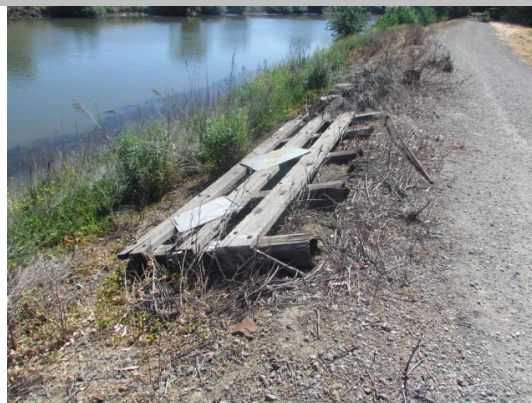
Photo 1 of 1 : FA_2016_RD0544_108_86_20160929_00050.jpg

LM Start	0.64	Rating **	M	Issue No.	86
LM End	0.64	Issue Type +	En	Location *	WS
Category	Earthen Levee			GPS Latitude/Longitude	
				Start	End
Item	Encroachments			37.863972 °	37.863972 °
				-121.323443 °	-121.323443 °
DWR ID	DWR_RD0544_01_s_2015_86				
Comment Code					
SI : Sign					
Inspector Comment					
Old "dead end" sign on waterward slope.

Looking southeast at wooden sign on waterward slope.

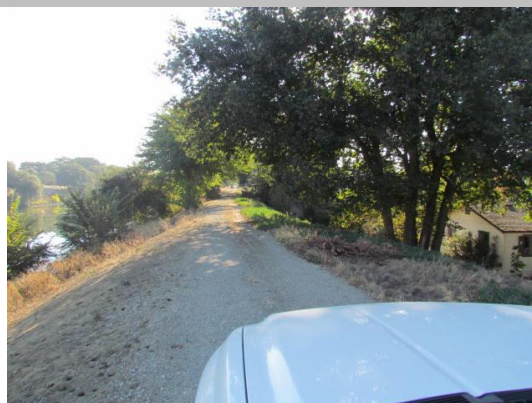
Photo 1 of 2 : FA_2016_RD0544_108_9_20160929_00011.jpg

LM Start	0.64	Rating **	U	Issue No.	9
LM End	0.70	Issue Type +	En	Location *	LS
Category	Earthen Levee			GPS Latitude/Longitude	
				Start	End
Item	Vegetation			37.863935 °	37.863599 °
				-121.323341 °	-121.322442 °
DWR ID	DWR_RD0544_01_s_2012_9				
Comment Code					
V6 : Landscaping					
Inspector Comment

Looking southwest at dense landscaping on landward slope fall 2015

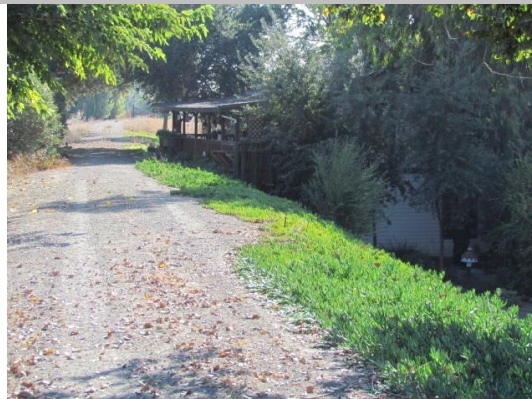
Photo 2 of 2 : FA_2016_RD0544_108_9_20160929_00012.jpg

LM Start	0.64	Rating **	U	Issue No.	9 (cont)	
LM End	0.70	Issue Type +	En	Location *	LS	
Category	Earthen Levee			GPS Latitude/Longitude		
				Start		End
Item	Vegetation			37.863935 °		37.863599 °
				-121.323341 °		-121.322442 °
DWR ID	DWR_RD0544_01_s_2012_9					
Comment Code						
V6 : Landscaping						
Inspector Comment

Looking south at landscaping on landward slope.

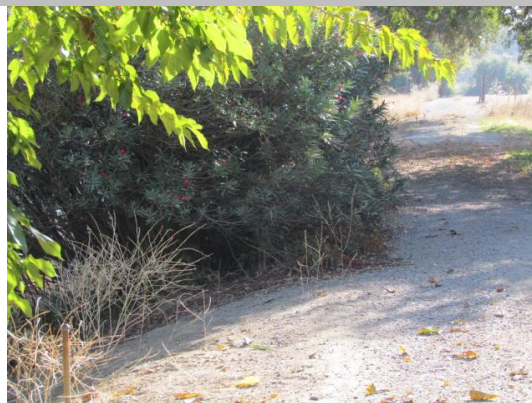
Photo 1 of 1 : FA_2016_RD0544_108_10_20160929_00013.jpg

LM Start	0.70	Rating **	U	Issue No.	10
LM End	0.70	Issue Type +	En	Location *	WS
Category	Earthen Levee			GPS Latitude/Longitude	
				Start	End
Item	Vegetation			37.863575 °	37.863575 °
				-121.322367 °	-121.322367 °
DWR ID	DWR_RD0544_01_s_2012_10				
Comment Code					
V6 : Landscaping					
Inspector Comment					
Oleander on waterward slope.

Looking south at dense oleanders on waterward slope fall 2015.

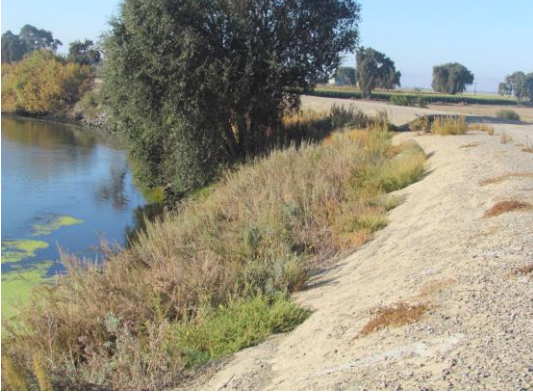
Photo 1 of 1 : FA_2016_RD0544_108_19_20161107_00135.jpg

Looking south at typical of dense veg on waterward slope.

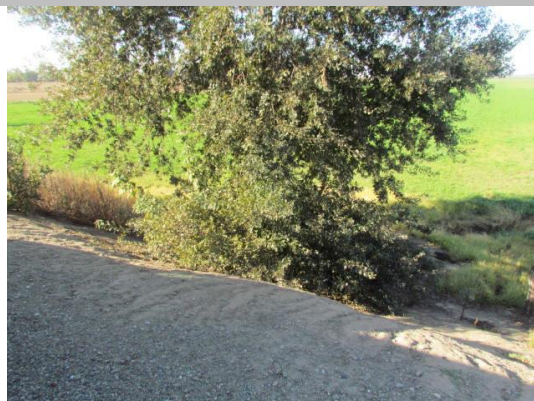
Photo 1 of 1 : FA_2016_RD0544_108_87_20160929_00051.jpg

LM Start	1.42	Rating **	U	Issue No.	87
LM End	1.48	Issue Type +	Ma	Location *	LS
Category	Earthen Levee			GPS Latitude/Longitude	
				Start	End
Item	Trim / Thin Trees			37.855948 °	37.855043 °
				-121.321250 °	-121.321122 °
DWR ID	DWR_RD0544_01_s_2015_87				
Comment Code					
T1 : Trim trees to at least five feet above ground level.					
Inspector Comment

Looking west at untrimmed tree at landward toe fall 2015.

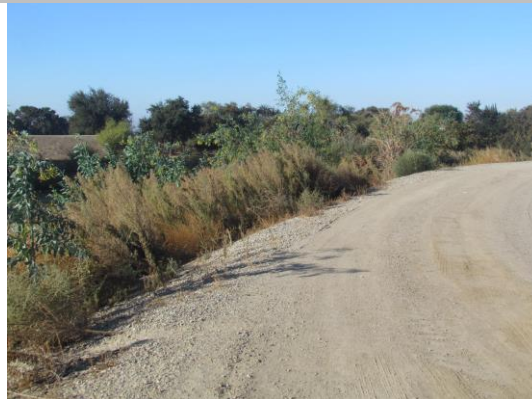
Photo 1 of 1 : FA_2016_RD0544_108_43_20161107_00137.jpg

LM Start	1.57	Rating **	U	Issue No.	43
LM End	1.76	Issue Type +	Ma	Location *	WS
Category	Earthen Levee			GPS Latitude/Longitude	
				Start	End
Item	Vegetation			37.854108 °	37.853980 °
				-121.321582 °	-121.324213 °
DWR ID	DWR_RD0544_01_s_2012_43				
Comment Code					
V2 : Remove the wild growth other than native grasses from the levee slopes.					
Inspector Comment					
Dense vegetation waterward slope.

Looking east at dense veg on waterward slope.

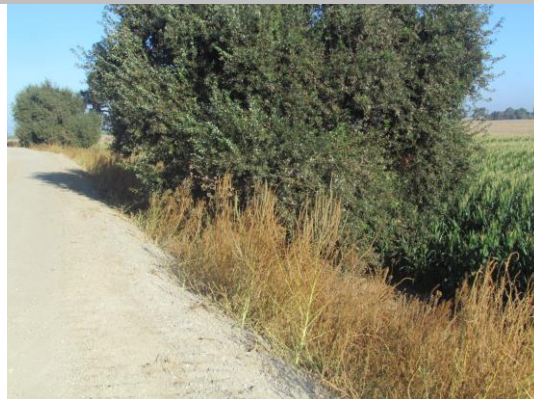
Photo 1 of 1 : FA_2016_RD0544_108_95_20161107_00138.jpg

LM Start	1.59	Rating **	U	Issue No.	95
LM End	1.59	Issue Type +	Ma	Location *	LS
Category	Earthen Levee			GPS Latitude/Longitude	
				Start	End
Item	Trim / Thin Trees			37.854299 °	37.854299 °
				-121.321865 °	-121.321865 °
DWR ID	DWR_RD0544_01_f_2014_95				
Comment Code					
T1 : Trim trees to at least five feet above ground level.					
Inspector Comment					
Untrimmed tree on landward slope.

Looking southwest at untrimmed tree on landward slope.

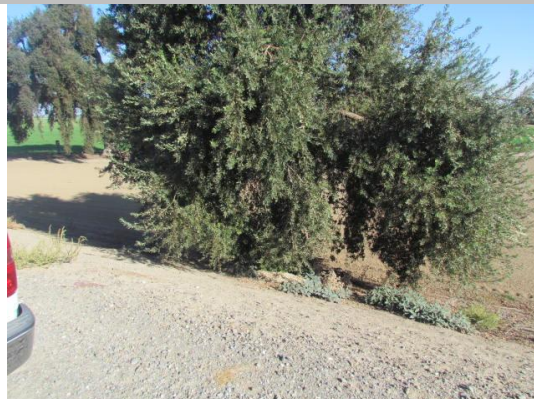
Photo 1 of 1 : FA_2016_RD0544_108_96_20160929_00059.jpg

LM Start	1.64	Rating **	U	Issue No.	96
LM End	1.64	Issue Type +	Ma	Location *	LS
Category	Earthen Levee			GPS Latitude/Longitude	
				Start	End
Item	Trim / Thin Trees			37.854681 °	37.854681 °
				-121.322493 °	-121.322493 °
DWR ID	DWR_RD0544_01_f_2014_96				
Comment Code					
T2 : Thin trees to allow visibility of the ground and room to flood fight.					
Inspector Comment

Looking at untrimmed tree on landward slope and toe.

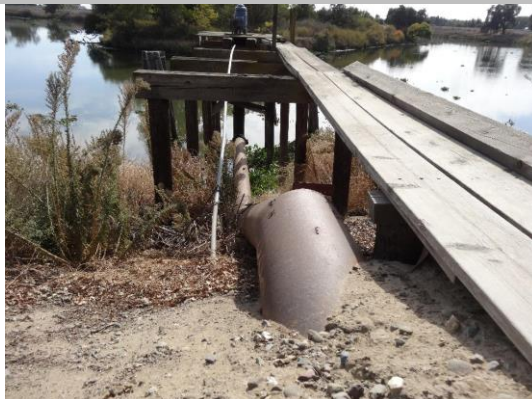
Photo 1 of 2 : UCIP_FA_2016_43023_41786.jpg

LM Start	1.72	Rating **	U	Issue No.	174	
LM End	1.72	Issue Type +	En	Location *	LS	
Category	Supplemental			GPS Latitude/Longitude		
				Start		End
Item	DWR UCIP Field Study			37.854506 °		37.854506 °
				-121.323886 °		-121.323886 °
DWR ID						
Comment Code						
Inspector Comment						
FS_ID:43023						
DS_ID:22648						
EP_NO: 4114						
Repair Type: Urgent						
Crossing Status: Found						
UCIP Comments: - levee depression on both sides of the levee.- 2-inch electric conduit on waterside and service pole on landside.Walkway in poor structural condition.						
FIELD_STRUCT_DESC: 18-inch steel pipe through the levee 2 feet below the crown, pump mounted on pile structure pier in the stream.						
Siphon breaker on the landward slope. Concrete standpipe at the toe of the landward slope. (App. No. 4114-Katie M. Feck) O&M Manual SJR 007, April 1964.						
FS Date: 10/29/2013

WS view: pipe, conduit, walkway, and pump on levee slope.

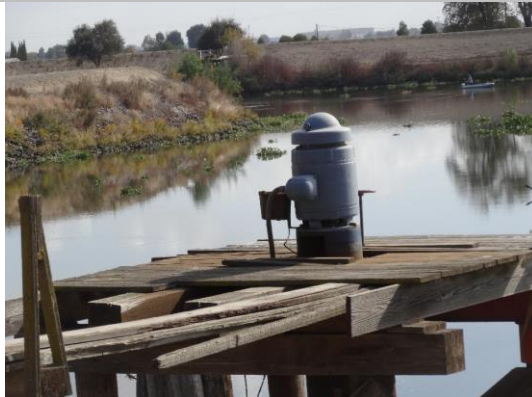
Photo 2 of 2 : UCIP_FA_2016_43023_41785.jpg

WS view: pump on wooden pile structure in the stream.

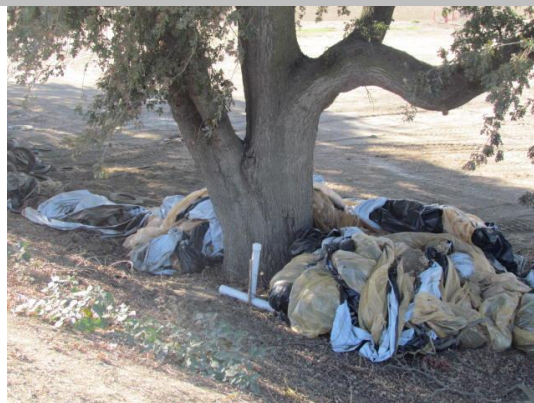
Photo 1 of 2 : FA_2016_RD0544_108_64_20160929_00044.jpg

LM Start	1.91	Rating **	U	Issue No.	64
LM End	1.93	Issue Type +	En	Location *	LS
Category	Earthen Levee			GPS Latitude/Longitude	
				Start	End
Item	Encroachments			37.852006 °	37.851746 °
				-121.323554 °	-121.323328 °
DWR ID	DWR_RD0544_01_f_2015_64				
Comment Code					
GA : Garbage					
Inspector Comment					
Plastic sheeting and rubber tires stored at landward toe.

Looking west at plastic sheeting stored at landward toe.

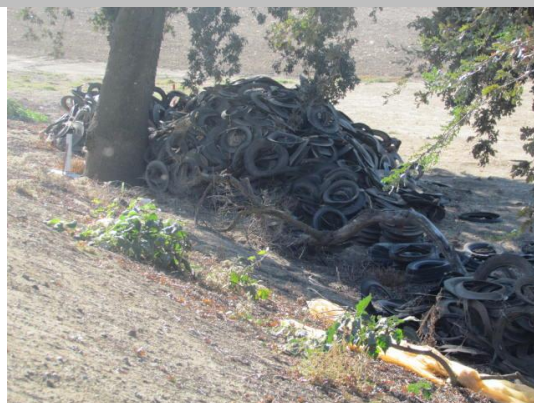
Photo 2 of 2 : FA_2016_RD0544_108_64_20160929_00045.jpg

Looking southwest at rubber tires stored at landward toe.

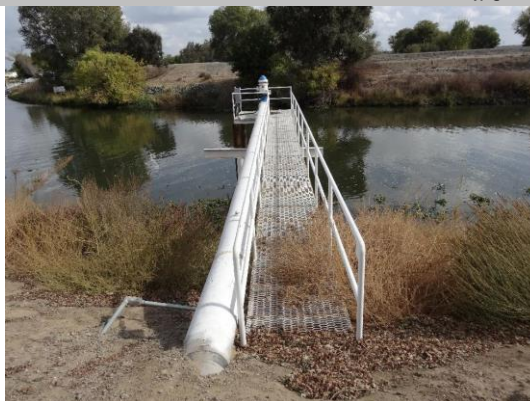
Photo 1 of 2 : UCIP_FA_2016_23945_42007.jpg

LM Start	2.25	Rating **	U	Issue No.	169
LM End	2.25	Issue Type +	En	Location *	WS
Category	Supplemental			GPS Latitude/Longitude	
				Start	End
Item	DWR UCIP Field Study			37.848225 °	37.848225 °
				-121.324868 °	-121.324868 °
DWR ID					
Comment Code					
Inspector Comment					
FS_ID:23945 DS_ID:22650 EP_NO: N/A Repair Type: Urgent Crossing Status: Found UCIP Comments: Siphon breaker on the landward slope not found. It has been removed and pipe plugged.Huge levee slope erosion on landside.2-inch electric conduit on waterside, service pole on landside. FIELD_STRUCT_DESC: 14-inch steel pipe through the levee, 2.0 feet below the crown, pump on pile structure in the stream. Steel walkway to the pump. 2-inch electric conduit on waterside, power pole on landside. O&M Manual SJR 007, April 1964. FS Date: 10/29/2013

WS view: steel pipe, walkway to the pump, conduit (bottom left) on levee slope.

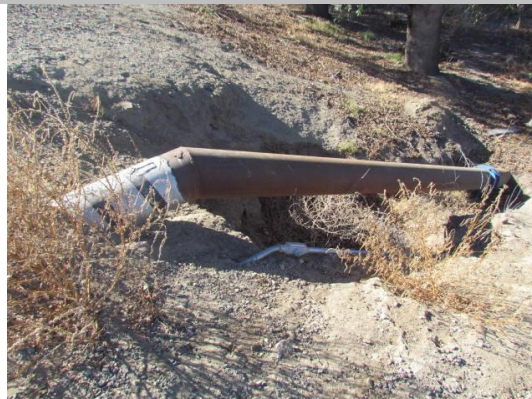
Photo 1 of 3 : FA_2016_RD0544_108_23_20160929_00017.jpg

LM Start	2.26	Rating **	U	Issue No.	23
LM End	2.26	Issue Type +	Ma	Location *	LS
Category	Earthen Levee			GPS Latitude/Longitude	
				Start	End
Item	Erosion / Bank Caving			37.848155 °	37.848155 °
				-121.324897 °	-121.324897 °
DWR ID	DWR_RD0544_01_s_2012_23				
Comment Code					
E2 : Schedule repair of erosion site prior to the next inspection.					
Inspector Comment					
Caving/erosion around irrigation pipe on landside slope.

Looking south at erosion around irrigation pipe on landside slope. (Fall 2014)

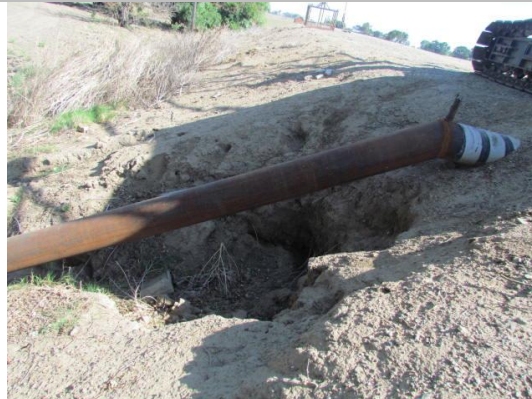
Photo 2 of 3 : FA_2016_RD0544_108_23_20160929_00018.jpg

Looking north at erosion under irrigation pipe on landside slope.

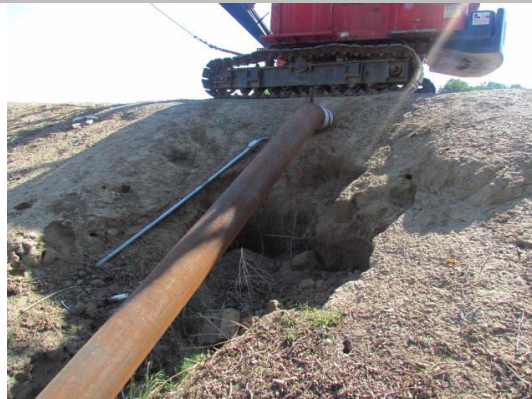
Photo 3 of 3 : FA_2016_RD0544_108_23_20160929_00019.jpg

Looking east at erosion under irrigation pipe on landside slope.

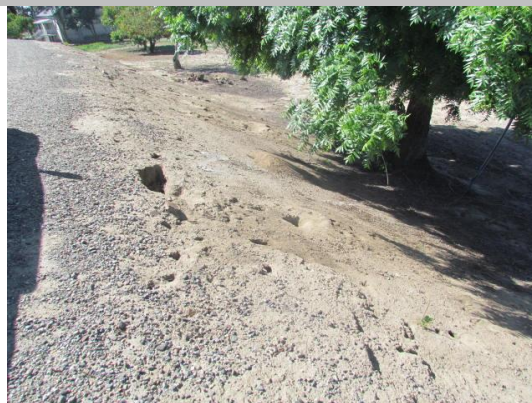
Photo 1 of 2 : FA_2016_RD0544_108_34_20160929_00025.jpg

LM Start	2.32	Rating **	M	Issue No.	34
LM End	2.36	Issue Type +	Ma	Location *	LS
Category	Earthen Levee			GPS Latitude/Longitude	
				Start	End
Item	Animal Control			37.847292 °	37.846743 °
				-121.324662 °	-121.324336 °
DWR ID	DWR_RD0544_01_s_2012_34				
Comment Code					
A1 : Exterminate rodents and backfill and compact or grout burrows.					
Inspector Comment					
Several rodent hole within this reach.

Looking south at several rodent holes on landward shoulder and slope.

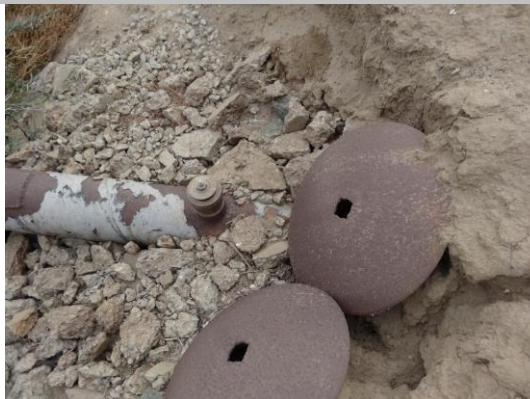
Photo 2 of 2 : UCIP_FA_2016_46671_44835.jpg

LM Start	2.43	Rating **	M	Issue No.	178 (cont)
LM End	2.43	Issue Type +	En	Location *	LS
Category	Supplemental			GPS Latitude/Longitude	
				Start	End
Item	DWR UCIP Field Study			37.845968 °	37.845968 °
				-121.323357 °	-121.323357 °
DWR ID					
Comment Code					
Inspector Comment					
FS_ID:46671 DS_ID:22654 EP_NO: N/A Repair Type: Non-Urgent Crossing Status: Found UCIP Comments: - soil around the siphon breaker eroded. FIELD_STRUCT_DESC: 8-inch pipe through the levee, 2 feet below the crown. Siphon breaker waterside slope. Pump on drainage channel bank. FS Date: 10/29/2013

WS view: exposed steel pipe and soil erosion around siphon breaker on levee slope.

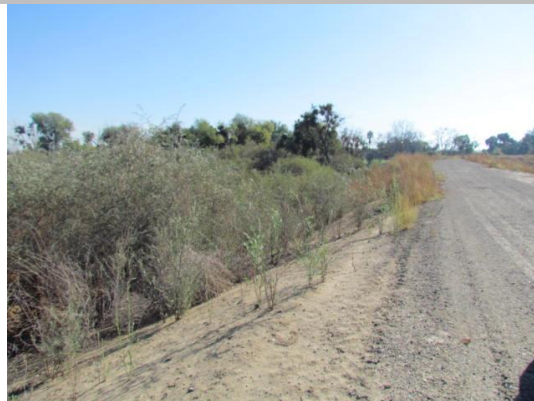
Photo 1 of 1 : FA_2016_RD0544_108_106_20160929_00064.jpg

LM Start	2.89	Rating **	U	Issue No.	106
LM End	3.16	Issue Type +	Ma	Location *	WS
Category	Earthen Levee			GPS Latitude/Longitude	
				Start	End
Item	Vegetation			37.840952 °	37.837588 °
				-121.319327 °	-121.317540 °
DWR ID	DWR_RD0544_01_s_2015_106				
Comment Code					
V2 : Remove the wild growth other than native grasses from the levee slopes.					
Inspector Comment					
Dense willows and vegetation waterward slope.

Looking southeast at dense willows (veg) on waterward slope and toe fall 2015.

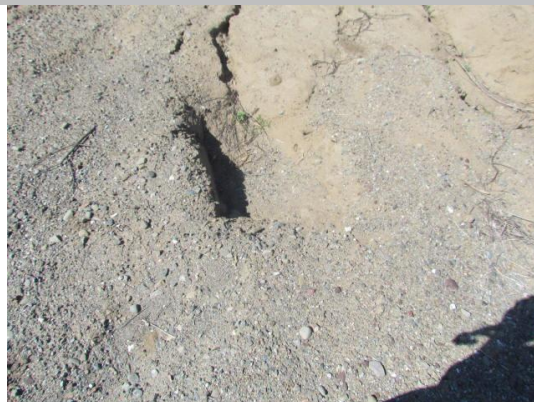
Photo 1 of 2 : FA_2016_RD0544_108_107_20160929_00065.jpg

LM Start	2.95	Rating **	M	Issue No.	107
LM End	2.96	Issue Type +	Ma	Location *	LS
Category	Earthen Levee			GPS Latitude/Longitude	
				Start	End
Item	Erosion / Bank Caving			37.840560 °	37.840467 °
				-121.318463 °	-121.318367 °
DWR ID	DWR_RD0544_01_s_2015_107				
Comment Code					
E1 : Note and monitor erosion site.					
Inspector Comment					
Several depressions on landward slope within this reach.

Looking south at depression on landward slope.

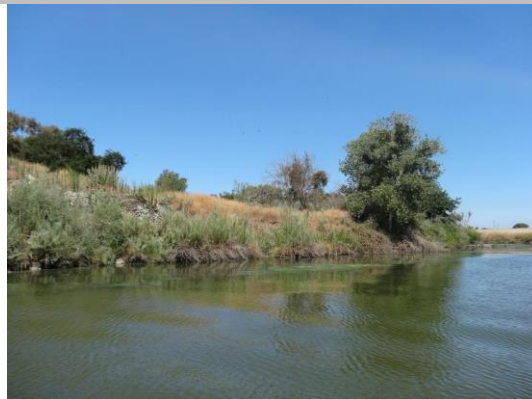
Photo 2 of 2 : SJR2016_RD0544U01RM49.67_3.jpg

LM Start	2.95	Rating **	U	Issue No.	46 (cont)	
LM End	2.95	Issue Type +	Ma	Location *	WS	
Category	Supplemental			GPS Latitude/Longitude		
				Start	End	
Item	DWR Erosion Survey			37.840697 °	37.840697 °	
				-121.318252 °	-121.318252 °	
DWR ID						
Comment Code						
Inspector Comment						
07/25/2016: No significant change observed.						
06/24/2015: No significant change observed.						
06/19/2014: No significant change observed.						
08/13/2013: Pump has been removed. A larger pocket erosion has been found at the erosion site.						
08/07/2012: The erosion is immediately upstream of a river bend.						
Dense vegetation is visible at the erosion site. [2016 Site ID:RD0544U01RM49.67]

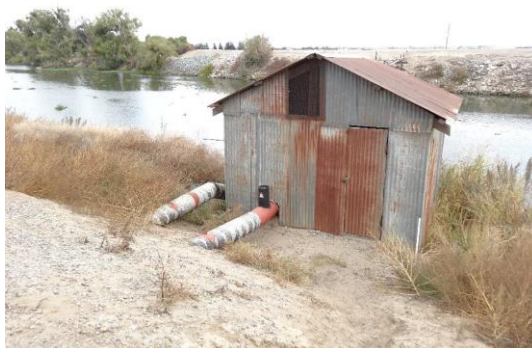
Photo 1 of 2 : UCIP_FA_2016_43025_42207.jpg

WS view: exposed steel pipes, levee slope, and pumphouse for 2nd pipe.

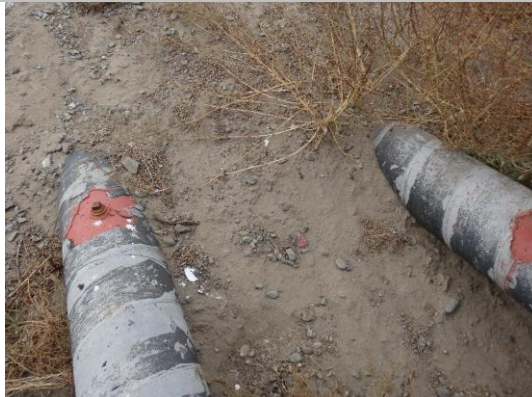
Photo 2 of 2 : UCIP_FA_2016_43025_42206.jpg

WS view: exposed steel pipes on levee slope.

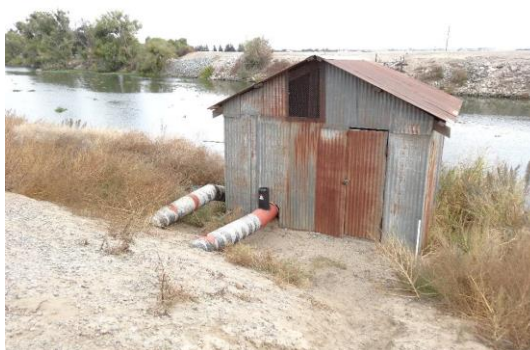
Photo 1 of 2 : UCIP_FA_2016_43026_44845.jpg

WS view: exposed steel pipes, levee slope, and pumphouse.

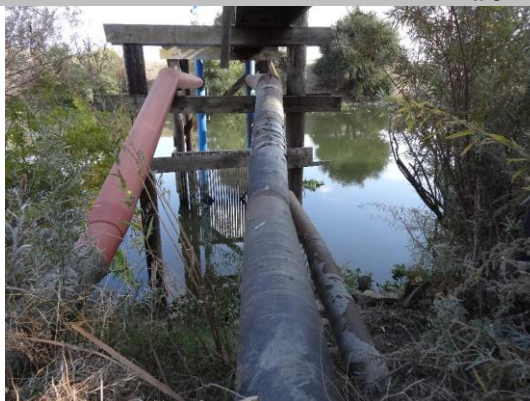
Photo 1 of 2 : UCIP_FA_2016_24893_44858.jpg

WS view: pipes, pumps, walkway to pump, and pile structure in the stream.

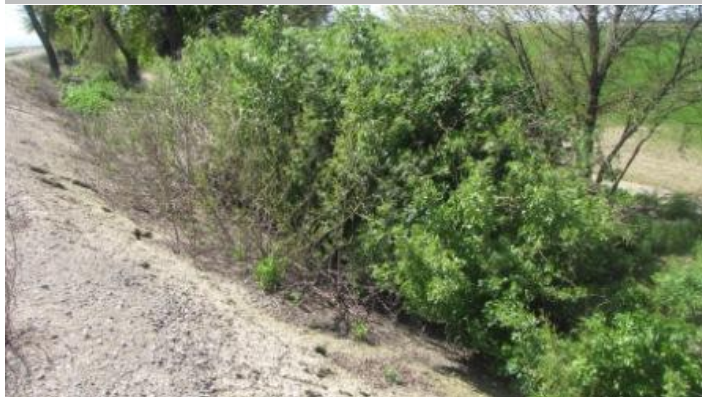
Photo 1 of 1 : FA_2016_RD0544_108_41_20160929_00033.jpg

LM Start	4.49	Rating **	U	Issue No.	41
LM End	4.49	Issue Type +	Ma	Location *	LS
Category	Earthen Levee			GPS Latitude/Longitude	
				Start	End
Item	Vegetation			37.822934 °	37.822934 °
				-121.316870 °	-121.316870 °
DWR ID	DWR_RD0544_01_s_2012_41				
Comment Code					
V4 : Elderberries are blocking visibility and flood fight capability.					
Inspector Comment

Looking south at elderberries on landside slope and toe.

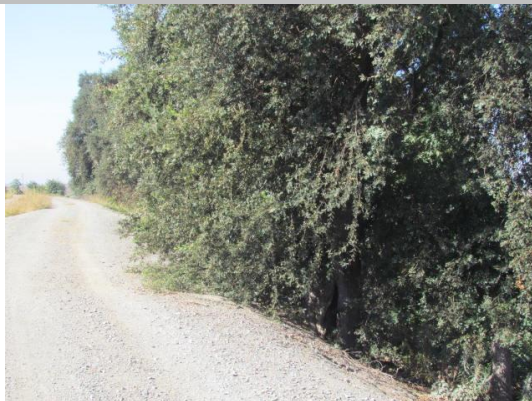
Photo 1 of 1 : FA_2016_RD0544_108_104_20160929_00062.jpg

LM Start	4.64	Rating **	U	Issue No.	104
LM End	4.68	Issue Type +	Ma	Location *	LS
Category	Earthen Levee			GPS Latitude/Longitude	
				Start	End
Item	Trim / Thin Trees			37.822033 °	37.821826 °
				-121.319432 °	-121.320071 °
DWR ID	DWR_RD0544_01_f_2014_104				
Comment Code					
T2 : Thin trees to allow visibility of the ground and room to flood fight.					
Inspector Comment					
Dense untrimmed trees on landward slope.

Looking southwest at dense untrimmed trees on landward slope fall 2015.

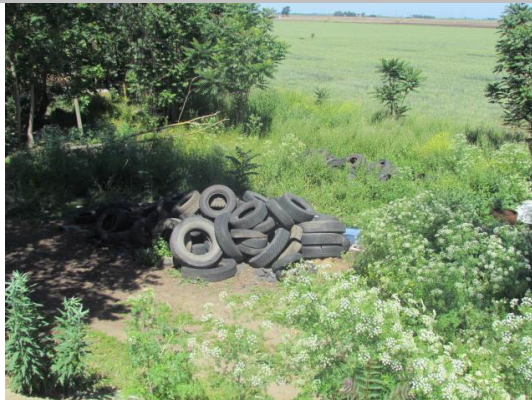
Photo 1 of 1 : FA_2016_RD0544_108_27_20160929_00020.jpg

LM Start	4.68	Rating **	U	Issue No.	27
LM End	4.68	Issue Type +	En	Location *	LS
Category	Earthen Levee			GPS Latitude/Longitude	
				Start	End
Item	Encroachments			37.821847 °	37.821847 °
				-121.320027 °	-121.320027 °
DWR ID	DWR_RD0544_01_s_2012_27				
Comment Code					
GA : Garbage					
Inspector Comment					
Tires stock pile on landward toe.

Looking west at tires stock pile on landward berm.

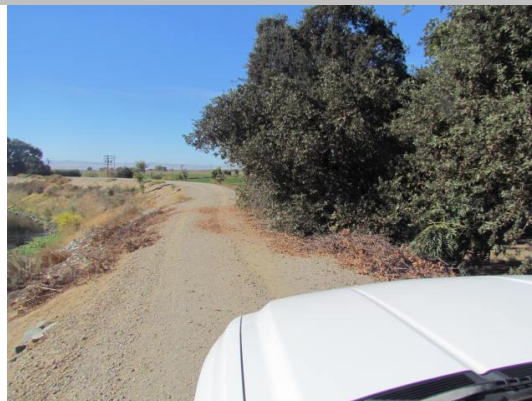
Photo 1 of 1 : FA_2016_RD0544_108_105_20160929_00063.jpg

LM Start	4.69	Rating **	U	Issue No.	105
LM End	4.69	Issue Type +	Ma	Location *	LS
Category	Earthen Levee			GPS Latitude/Longitude	
				Start	End
Item	Trim / Thin Trees			37.821775 °	37.821775 °
				-121.320203 °	-121.320203 °
DWR ID	DWR_RD0544_01_f_2014_105				
Comment Code					
T2 : Thin trees to allow visibility of the ground and room to flood fight.					
Inspector Comment					
Tree has overgrown onto levee crown.

Looking south at overgrown tree on landward shoulder.

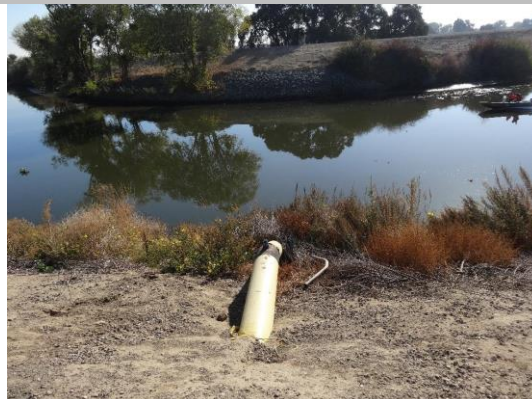
Photo 1 of 2 : UCIP_FA_2016_24894_44864.jpg

LM Start	4.75	Rating **	U	Issue No.	167
LM End	4.75	Issue Type +	En	Location *	LS
Category	Supplemental			GPS Latitude/Longitude	
				Start	End
Item	DWR UCIP Field Study			37.821153 °	37.821153 °
				-121.320995 °	-121.320995 °
DWR ID					
Comment Code					
Inspector Comment					
FS_ID:24894					
DS_ID:22661					
EP_NO: N/A					
Repair Type: Urgent					
Crossing Status: Found					
UCIP Comments: - huge erosion on landside slope due to leaky pipe.- small depression on waterside slope.					
FIELD_STRUCT_DESC: 12-inch diameter steel pipe through the levee, 4.4 feet below crown. Pump house on the landward slope. Pressure relief valve on the landside slope. Concrete distribution box at toe of landward slope. O&M Manual SJR 007, April 1964.					
FS Date: 10/31/2013

WS view: exposed steel pipe on levee slope.

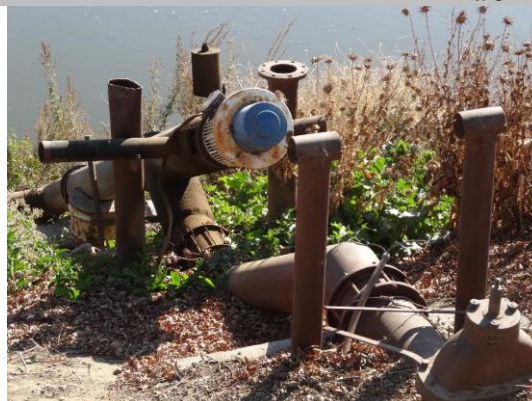
Photo 1 of 2 : UCIP_FA_2016_42962_42877.jpg

LM Start	4.78	Rating **	M	Issue No.	177
LM End	4.78	Issue Type +	En	Location *	WS
Category	Supplemental			GPS Latitude/Longitude	
				Start	End
Item	DWR UCIP Field Study			37.820691 °	37.820691 °
				-121.321159 °	-121.321159 °
DWR ID					
Comment Code					
Inspector Comment					
FS_ID:42962 DS_ID:22662 EP_NO: 1738 Repair Type: Non-Urgent Crossing Status: Found UCIP Comments: Appears abandoned and if so should be done so properly. No handle on gatevalve on WS slope. FIELD_STRUCT_DESC: 12-inch diameter steel pipe through the levee, 6.0 feet below the crown. Gate valve on the waterward slope. Slant pump on the waterward slope. An electric conduit on landside, service pole on landside and two concrete standpipes on landside. (Permit No. 1738 - Barker Corp.) O&M Manual SJR 007, April 1964. FS Date: 10/31/2013

WS view: slant pump on steel framed support, gate valve, and headwall on levee slope.

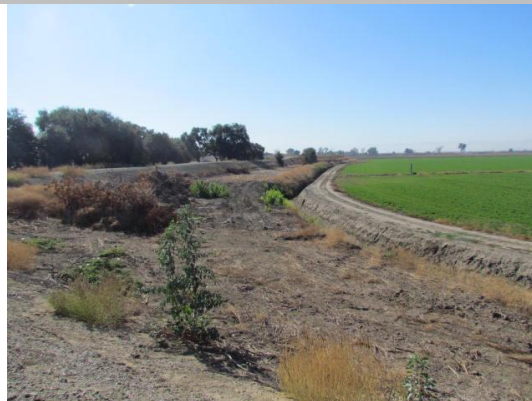
Photo 1 of 2 : FA_2016_RD0544_108_33_20160929_00023.jpg

LM Start	4.95	Rating **	M	Issue No.	33
LM End	5.26	Issue Type +	Ma	Location *	LS
Category	Earthen Levee			GPS Latitude/Longitude	
				Start	End
Item	Vegetation			37.818718 °	37.814662 °
				-121.319508 °	-121.320302 °
DWR ID	DWR_RD0544_01_s_2012_33				
Comment Code					
V2 : Remove the wild growth other than native grasses from the levee slopes.					
Inspector Comment					
Vegetation has been sprayed, and it should be monitored.

Looking southwest at cleared landward slope and berm fall 2015.

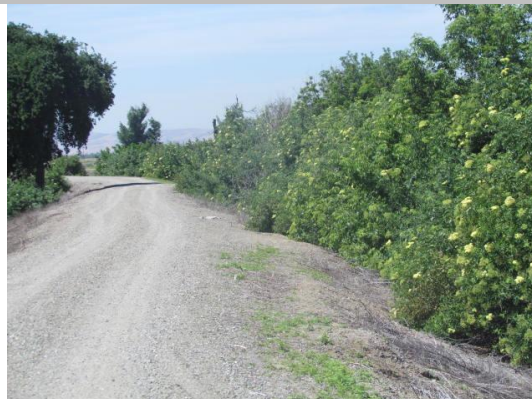
Photo 1 of 2 : FA_2016_RD0544_108_18_20160929_00015.jpg

Looking south at dense vegetation on landward slope and toe. (Spring 2015)

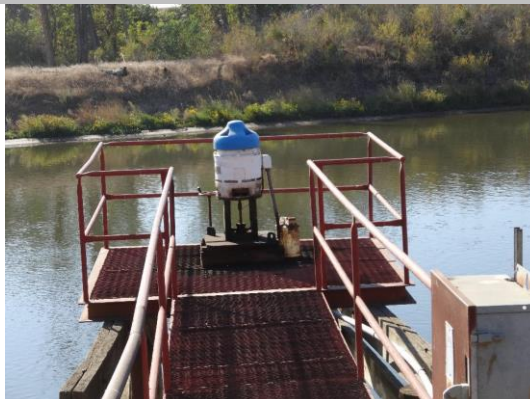
Photo 2 of 2 : UCIP_FA_2016_24233_42871.jpg

LM Start	5.71	Rating **	M	Issue No.	171 (cont)	
LM End	5.71	Issue Type +	En	Location *	LS	
Category	Supplemental			GPS Latitude/Longitude		
				Start	End	
Item	DWR UCIP Field Study			37.811193 °	37.811193 °	
				-121.323532 °	-121.323532 °	
DWR ID						
Comment Code						
Inspector Comment						
FS_ID:24233 DS_ID:22664 EP_NO: N/A Repair Type: Non-Urgent Crossing Status: Found UCIP Comments: - 2-inch electric conduit on waterside- service pole on landside.- needs a cover on pressure relief valve. FIELD_STRUCT_DESC: 16-inch steel pipe and electrical conduit through the levee, 5.3 feet below the crown, pump mounted on pile structure in the stream. Steel walkway to the pump. Two 36-inch concrete stand pipes on the landward side. United States Army Corps of Engineers, installation 1962. O&M Manual SJR 007, April 1964. FS Date: 10/31/2013

WS view: pump on pile structure in the stream. Oil leaking pump.

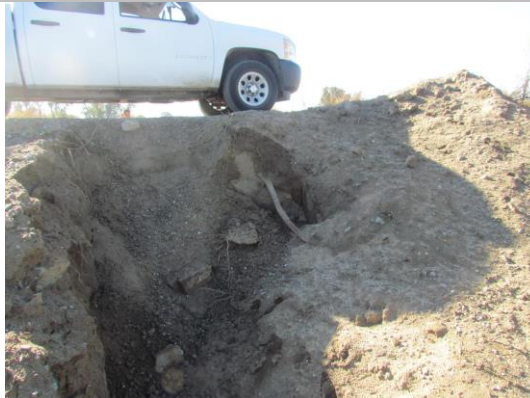
Photo 1 of 3 : FA_2016_RD0544_108_115_20161107_00147.jpg

LM Start	5.72	Rating **	U	Issue No.	115
LM End	5.72	Issue Type +	Ma	Location *	LS
Category	Earthen Levee			GPS Latitude/Longitude	
				Start	End
Item	Slope Stability			37.811225 °	37.811225 °
				-121.323575 °	-121.323575 °
DWR ID	DWR_RD0544_01_s_2015_115				
Comment Code					
S2 : Repair the levee slope damaged by foot traffic and prevent access where possible.					
Inspector Comment					
Landowner excavated hole above pipe.Large hole left on landward shoulder and slope. Call LMA about repair.

Looking west at large excavation on landward slope.

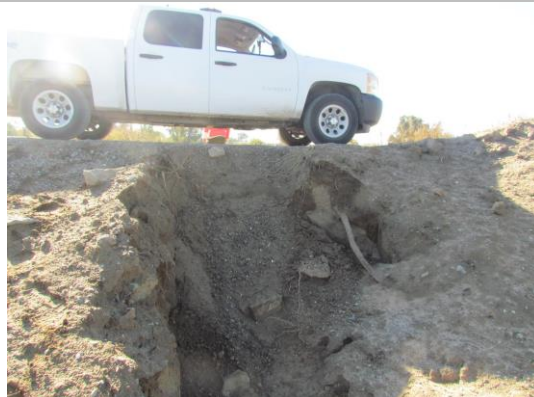
Photo 2 of 3 : FA_2016_RD0544_108_115_20161107_00146.jpg

Looking westly at large excavation on landward slope.

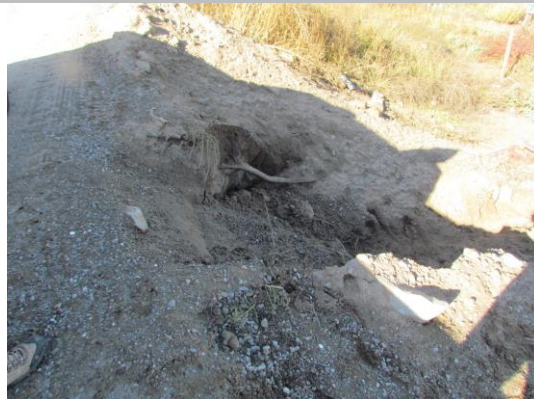
Photo 3 of 3 : FA_2016_RD0544_108_115_20161107_00148.jpg

Looking south at large excavation on landward slope.

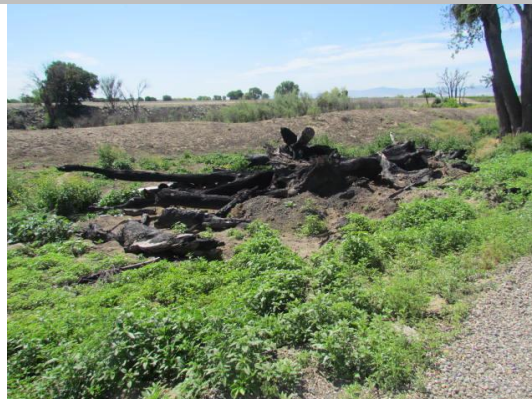
Photo 1 of 2 : FA_2016_RD0544_108_124_20160929_00083.jpg

LM Start	5.82	Rating **	U	Issue No.	124
LM End	5.82	Issue Type +	En	Location *	LS
Category	Earthen Levee			GPS Latitude/Longitude	
				Start	End
Item	Encroachments			37.811049 °	37.811049 °
				-121.325451 °	-121.325451 °
DWR ID	DWR_RD0544_01_s_2016_124				
Comment Code					
TR : Tree or limb					
Inspector Comment

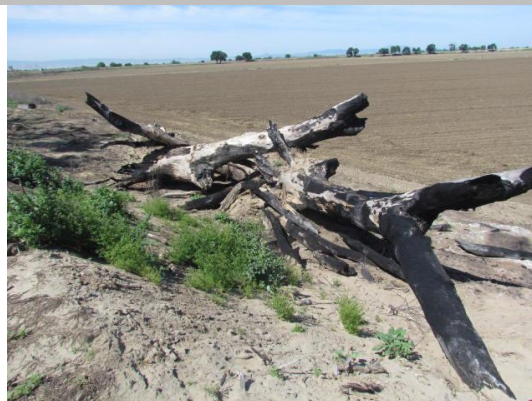
Photo 2 of 2 : FA_2016_RD0544_108_124_20160929_00084.jpg

Looking east at tree limbs on waterward slope.

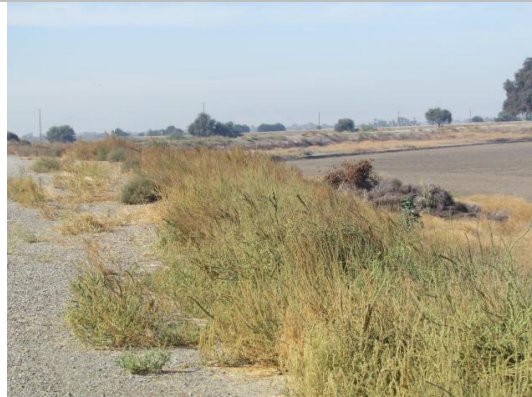
Photo 1 of 2 : FA_2016_RD0544_109_3_20160929_00002.jpg

LM Start	0.03	Rating **	M	Issue No.	3
LM End	0.17	Issue Type +	Ma	Location *	LS
Category	Earthen Levee			GPS Latitude/Longitude	
				Start	End
Item	Vegetation			37.808603 °	37.808213 °
				-121.328719 °	-121.331241 °
DWR ID	DWR_RD0544_02_s_2012_3				
Comment Code					
V2 : Remove the wild growth other than native grasses from the levee slopes.					
Inspector Comment

Looking south at dense veg on landward slope and toe fall 2015.

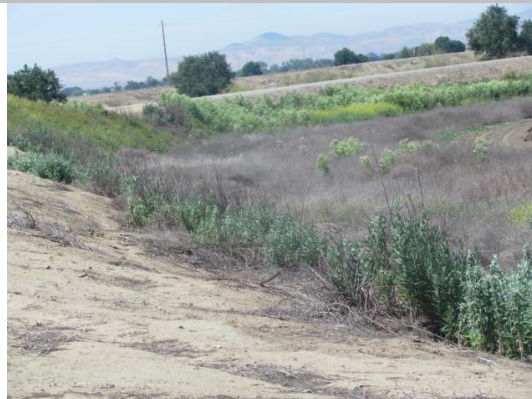
Photo 2 of 2 : FA_2016_RD0544_109_3_20160929_00003.jpg

Looking south at dense vegetation at landward toe spring 2014.

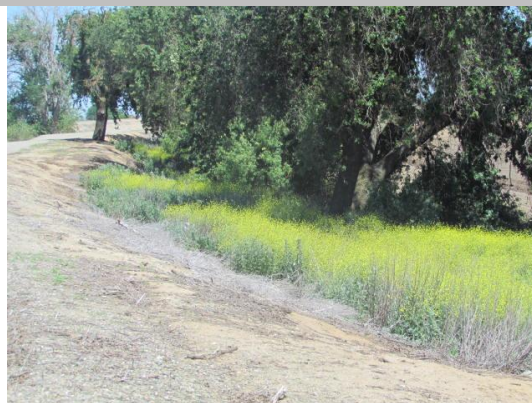
Photo 1 of 1 : FA_2016_RD0544_109_1_20160929_00001.jpg

LM Start	0.43	Rating **	M	Issue No.	1
LM End	1.12	Issue Type +	Ma	Location *	LS
Category	Earthen Levee			GPS Latitude/Longitude	
				Start	End
Item	Vegetation			37.810250 °	37.819452 °
				-121.334933 °	-121.333755 °
DWR ID	DWR_RD0544_02_s_2012_1				
Comment Code					
V2 : Remove the wild growth other than native grasses from the levee slopes.					
Inspector Comment

Looking southwest at dense vegetation at landward toe.

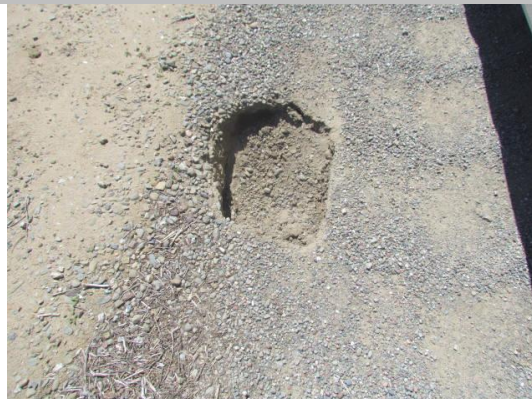
Photo 1 of 1 : FA_2016_RD0544_109_46_20160929_00041.jpg

LM Start	0.64	Rating **	U	Issue No.	46
LM End	0.64	Issue Type +	Ma	Location *	LS
Category	Earthen Levee			GPS Latitude/Longitude	
				Start	End
Item	Erosion / Bank Caving			37.813197 °	37.813197 °
				-121.335055 °	-121.335055 °
DWR ID	DWR_RD0544_02_s_2015_46				
Comment Code					
E1 : Note and monitor erosion site.					
Inspector Comment					
Depression greater than one inch deep and greater that three inches on landward shoulder

Looking at depression on landward shoulder.

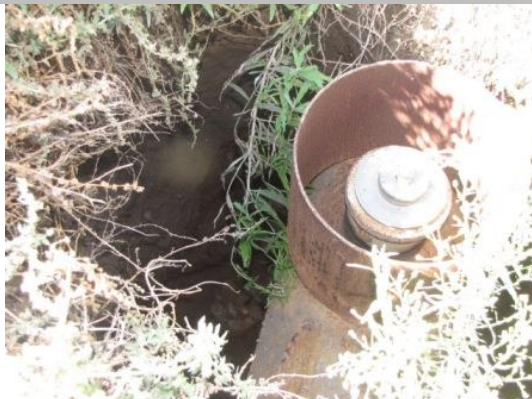
Photo 2 of 6 : FA_2016_RD0544_109_8_20160929_00008.jpg

Looking at caving around 10" siphon pipe on waterside shoulder.

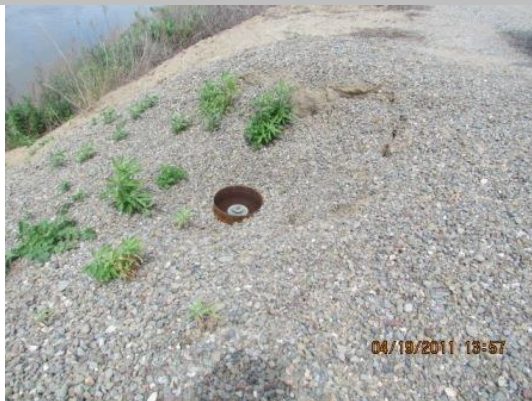
Photo 3 of 6 : FA_2016_RD0544_109_8_20160929_00009.jpg

Looking south at depression greater than 6" on waterside shoulder.

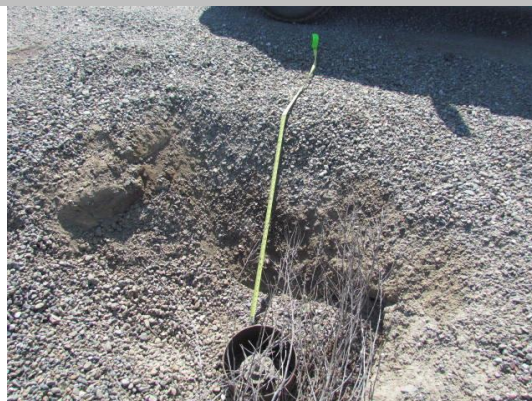
Photo 5 of 6 : FA_2016_RD0544_109_8_20160929_00012.jpg

Looking west at caving around siphon on waterside shoulder. (Spring 2012)

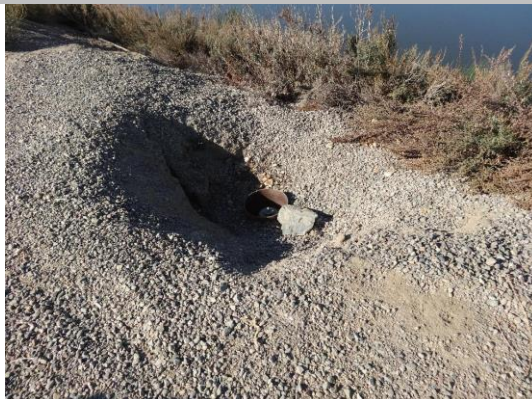
Photo 1 of 2 : UCIP_FA_2016_24903_44882.jpg

LM Start	0.78	Rating **	U	Issue No.	70
LM End	0.78	Issue Type +	En	Location *	WS
Category	Supplemental			GPS Latitude/Longitude	
				Start	End
Item	DWR UCIP Field Study			37.815098 °	37.815098 °
				-121.333903 °	-121.333903 °
DWR ID					
Comment Code					
Inspector Comment					
FS_ID:24903 DS_ID:22665 EP_NO: N/A Repair Type: Urgent Crossing Status: Found UCIP Comments: - 8 ft X 7 ft X 4 ft depression around siphon breaker on waterside slope.- no pipe visible on waterside due to dense vegetation.- electric conduit and service pole on landside. FIELD_STRUCT_DESC: 12-inch steel pipe through the levee, 4.0 feet below the crown. Pump in drain ditch on the landward side. Siphon breaker on waterside levee slope. FS Date: 10/31/2013

WS view: depression on levee slope around siphon breaker.

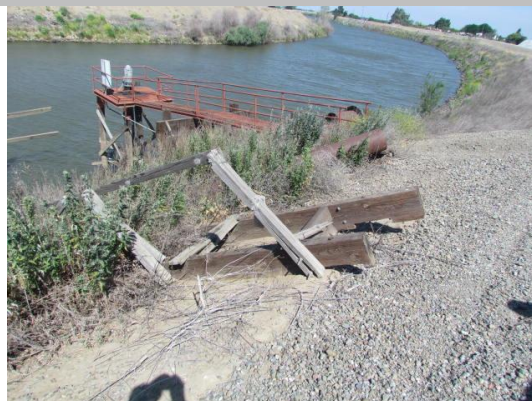
Photo 1 of 1 : FA_2016_RD0544_109_6_20160929_00004.jpg

LM Start	1.01	Rating **	M	Issue No.	6
LM End	1.01	Issue Type +	En	Location *	WS
Category	Earthen Levee			GPS Latitude/Longitude	
				Start	End
Item	Encroachments			37.818100 °	37.818100 °
				-121.332750 °	-121.332750 °
DWR ID	DWR_RD0544_02_s_2012_6				
Comment Code					
GA : Garbage					
Inspector Comment					
Discarded wooden catwalk on waterward slope.

Looking southeast at garbage on waterside shoulder and slope.

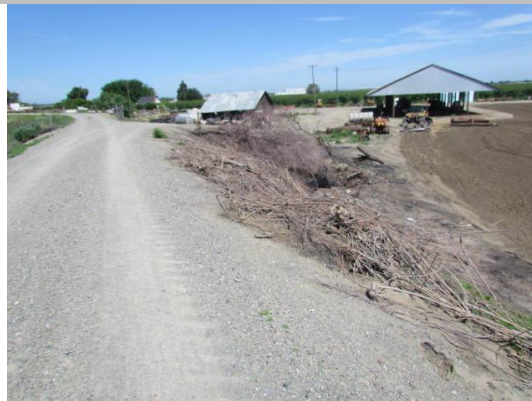
Photo 1 of 1 : FA_2016_RD0544_109_20_20160929_00028.jpg

LM Start	1.12	Rating **	U	Issue No.	20
LM End	1.12	Issue Type +	En	Location *	LS
Category	Earthen Levee			GPS Latitude/Longitude	
				Start	End
Item	Encroachments			37.819530 °	37.819530 °
				-121.333827 °	-121.333827 °
DWR ID	DWR_RD0544_02_s_2012_20				
Comment Code					
PR : Prunings					
Inspector Comment					
Landowner is stock piling prunings on landward slope and toe.

Looking southwest at pruning piles on landward slope.

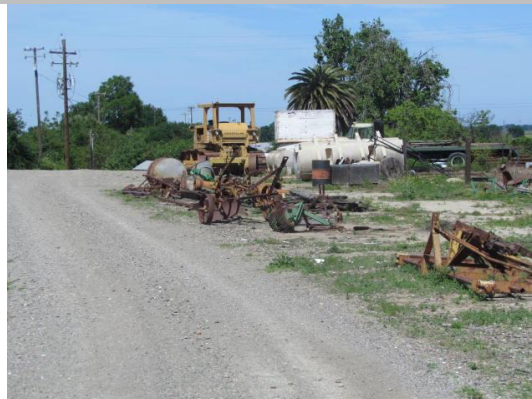
Photo 1 of 4 : FA_2016_RD0544_109_18_20160929_00024.jpg

Looking southwest at farm equipment stored on landward landing. (spring 2016)

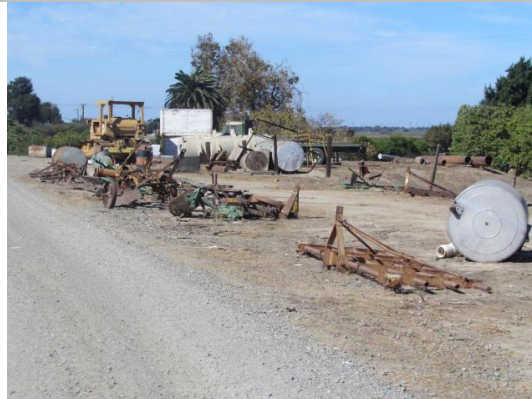
Photo 2 of 4 : FA_2016_RD0544_109_18_20160929_00025.jpg

Looking southwest at equipment stored on landward shoulder. (spring 2015)

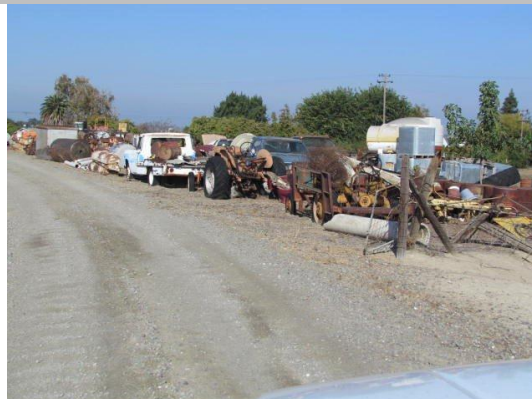
Photo 4 of 4 : FA_2016_RD0544_109_18_20160929_00027.jpg

LM Start	1.15	Rating **	M	Issue No.	18 (cont)	
LM End	1.22	Issue Type +	En	Location *	LS	
Category	Earthen Levee			GPS Latitude/Longitude		
				Start		End
Item	Encroachments			37.819830 °	37.820235 °	
				-121.334233 °	-121.335268 °	
DWR ID	DWR_RD0544_02_s_2012_18					
Comment Code						
AV : Abandoned vehicles						
Inspector Comment						
Vehicles and farm equipment stored on landside for several years. Area is defined a oversized levee. Landowner is in the process of moving items from landward shoulder.

Looking southwest at farm equipment, vehicles, and other items stored on landside landing. (spring 2013)

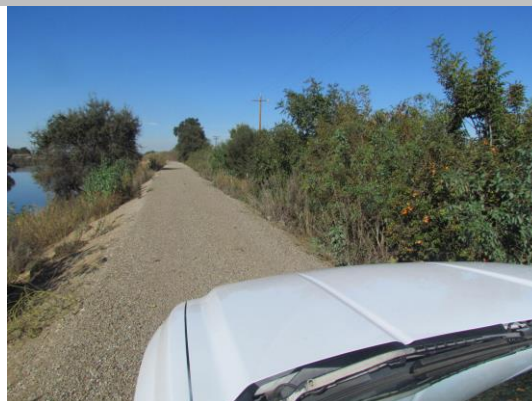
Photo 1 of 2 : FA_2016_RD0544_109_49_20161107_00087.jpg

LM Start	1.30	Rating **	U	Issue No.	49
LM End	1.40	Issue Type +	Ma	Location *	WS
Category	Earthen Levee			GPS Latitude/Longitude	
				Start	End
Item	Vegetation			37.820767 °	37.821582 °
				-121.336611 °	-121.338102 °
DWR ID	DWR_RD0544_02_f_2014_49				
Comment Code					
V2 : Remove the wild growth other than native grasses from the levee slopes.					
Inspector Comment					
Tobacco plants on waterward slope.

Looking southwest at dense veg on landward slope. (Fall 2016)

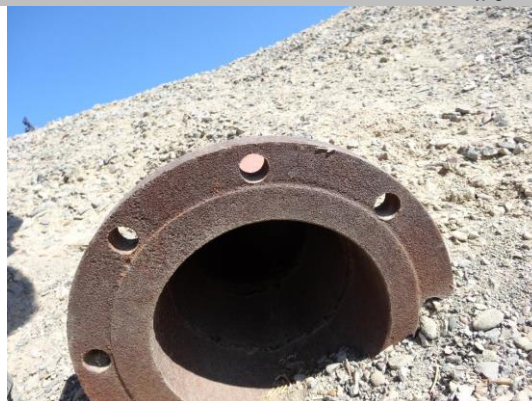
Photo 1 of 2 : UCIP_FA_2016_46674_44890.jpg

WS view: steel pipe on levee slope with opened end.

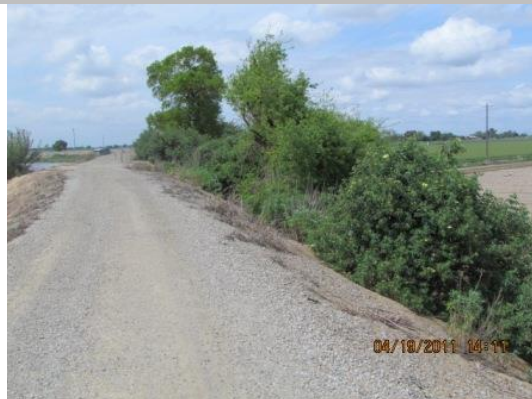
Photo 1 of 2 : FA_2016_RD0544_109_10_20160929_00018.jpg

LM Start	1.38	Rating **	U	Issue No.	10 (cont)
LM End	1.38	Issue Type +	Ma	Location *	LS

Looking southwest at elderberries on landside slope.

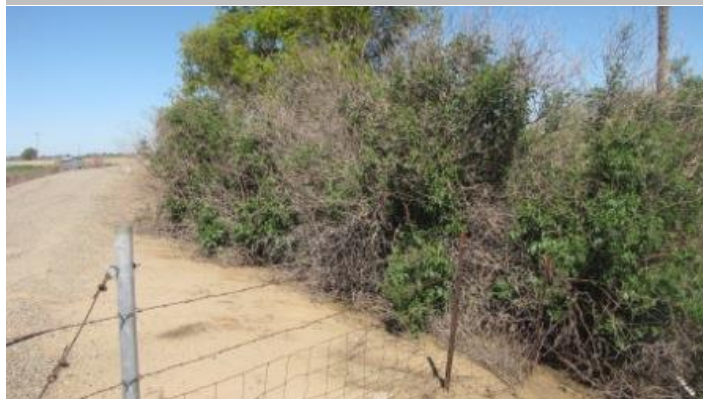
Photo 2 of 2 : FA_2016_RD0544_109_10_20160929_00019.jpg

Looking south at elderberries on landside slope and toe.

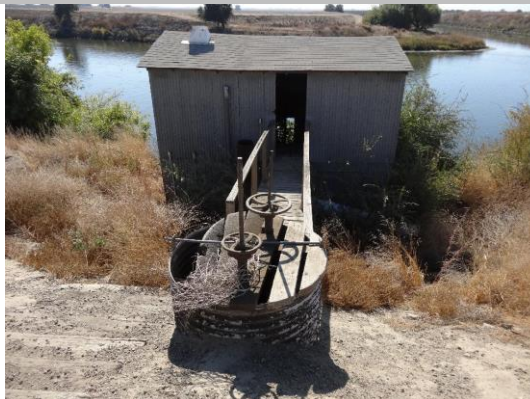
Photo 1 of 2 : UCIP_FA_2016_24288_42947.jpg

LM Start	1.51	Rating **	M	Issue No.	73
LM End	1.51	Issue Type +	En	Location *	LS
Category	Supplemental			GPS Latitude/Longitude	
				Start	End
Item	DWR UCIP Field Study			37.822415 °	37.822415 °
				-121.339699 °	-121.339699 °
DWR ID					
Comment Code					
Inspector Comment					
FS_ID:24288					
DS_ID:22669					
EP_NO: N/A					
Repair Type: Non-Urgent					
Crossing Status: Found					
UCIP Comments: - two pumps with 16" steel pipe and an abandoned pump with 10" pipe inside pump house.- CMP riser cover needs repair. - electric conduits on waterside and power pole on landside.					
FIELD_STRUCT_DESC: 24-inch steel pipe through the levee, 14.0 feet below the crown. Pump in pump house on the waterward berm. Slide gate in CM pipe riser on the waterward slope. Two CM cutoff walls. Distribution box and power pole on landward toe. O&M Manual SJR 007, April 1964.					
FS Date: 10/31/2013

WS view: slide gate in CMP riser, walkway, and pumphouse on levee slope.

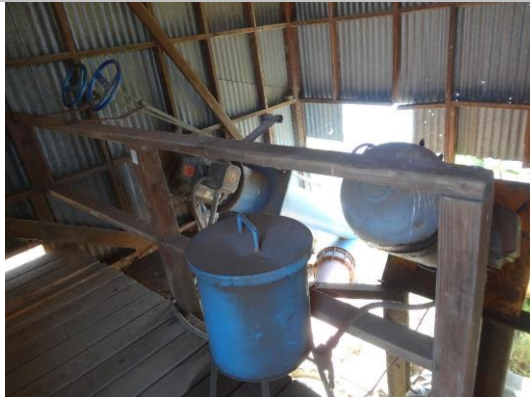
Photo 2 of 2 : UCIP_FA_2016_24288_42946.jpg

WS view: two pumps discharges water into CMP riser on levee slope.

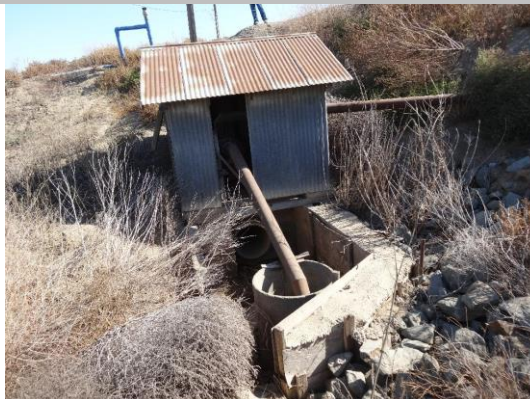
Photo 1 of 2 : UCIP_FA_2016_24907_44895.jpg

LM Start	1.52	Rating **	M	Issue No.	71
LM End	1.52	Issue Type +	En	Location *	LS
Category	Supplemental			GPS Latitude/Longitude	
				Start	End
Item	DWR UCIP Field Study			37.822445 °	37.822445 °
				-121.339910 °	-121.339910 °
DWR ID					
Comment Code					
Inspector Comment					
FS_ID:24907					
DS_ID:24716					
EP_NO: N/A					
Repair Type: Non-Urgent					
Crossing Status: Found					
UCIP Comments: No pipe and appurtenances found on waterside. Looks abandoned.					
FIELD_STRUCT_DESC: An abandoned 8-inch steelpipe through levee. Pump house on landside toe. Air vent in CMP riser on landside shoulder. Outlet on waterside not visible. No positive closure. Appears abandoned.					
FS Date: 10/31/2013

LS view: pipe, pump house, and appurtenances on levee slope.

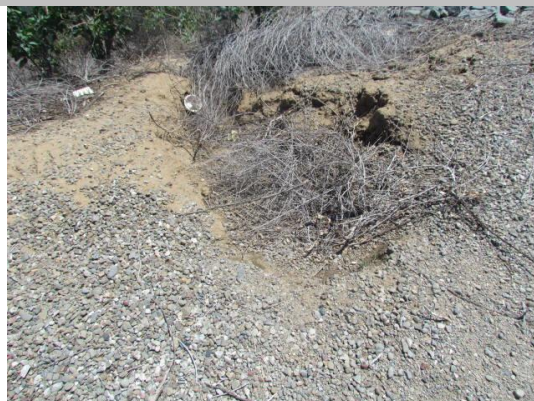
Photo 1 of 2 : FA_2016_RD0544_109_38_20160929_00038.jpg

LM Start	1.86	Rating **	U	Issue No.	38
LM End	1.86	Issue Type +	Ma	Location *	WS
Category	Earthen Levee			GPS Latitude/Longitude	
				Start	End
Item	Erosion / Bank Caving			37.817983 °	37.817983 °
				-121.341682 °	-121.341682 °
DWR ID	DWR_RD0544_02_s_2015_38				
Comment Code					
E1 : Note and monitor erosion site.					
Inspector Comment					
Erosion/Caving on waterward shoulder and slope 18" x 6" x 15'.

Looking southeast at erosion/caving on waterward slope.

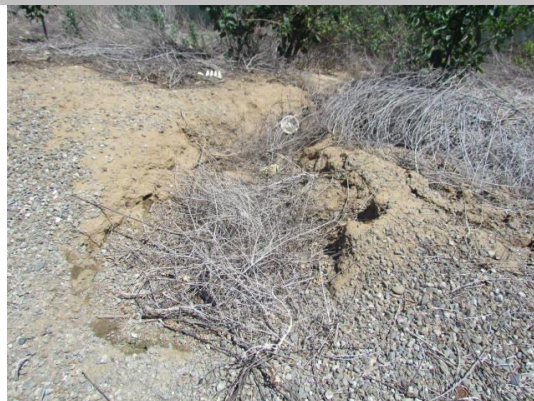
Photo 2 of 2 : FA_2016_RD0544_109_38_20160929_00039.jpg

Looking east at erosion/caving on waterward slope.

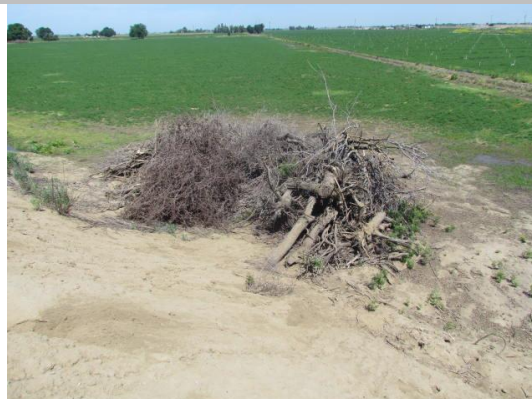
Photo 1 of 1 : FA_2016_RD0544_109_57_20160929_00049.jpg

Looking west at pruning pile at landward toe.(Spring 2015)

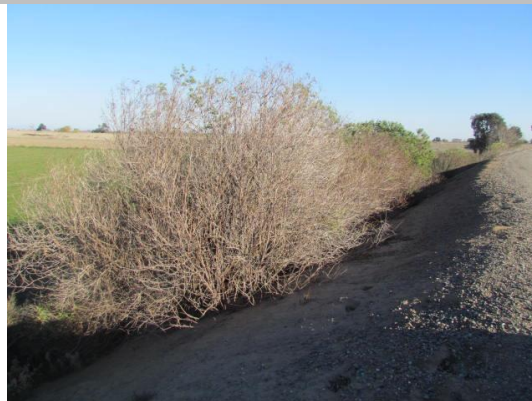
Photo 1 of 1 : FA_2016_RD0544_109_13_20160929_00022.jpg

Looking northwest at elderberries on landside slope and toe.

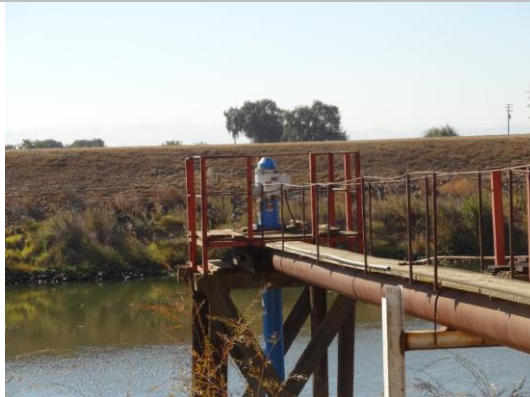
Photo 2 of 2 : UCIP_FA_2016_41731_42953.jpg

LM Start	2.21	Rating **	M	Issue No.	77 (cont)
LM End	2.21	Issue Type +	En	Location *	WS
Category	Supplemental			GPS Latitude/Longitude	
				Start	End
Item	DWR UCIP Field Study			37.820694 °	37.820694 °
				-121.346067 °	-121.346067 °
DWR ID					
Comment Code					
Inspector Comment					
FS_ID:41731 DS_ID:22675 EP_NO: N/A Repair Type: Non-Urgent Crossing Status: Found UCIP Comments: - soil erosion on landside slope.- new pump and pipe (according to the owner- three months old)- electric conduit through levee, service pole on landside. FIELD_STRUCT_DESC: 16-inch steel pipe and electric conduit through the levee, 3.0 feet below the crown. Pump on pile structure in the stream. Pressure breaker on the landward slope. Pipe exposed on both slopes and the berm. O&M Manual SJR 007, April 1964. FS Date: 10/31/2013

WS view: closer view of pipe, walkway, and pump on pile structure.
